Manhole Inspection Summary

Manhole # S29KK1018MH

Location Address: **4300 WICKFORD LN**

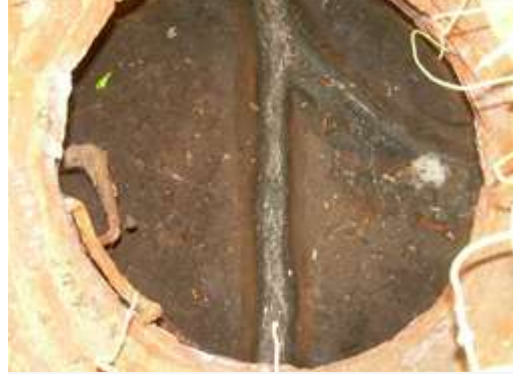
Top View

☒ **Debris** (not Condition related)

☒ **Corroded**

☒ **Evidence Of Surcharge**

Corroded steps. Evidence of surcharge - Bench debris.

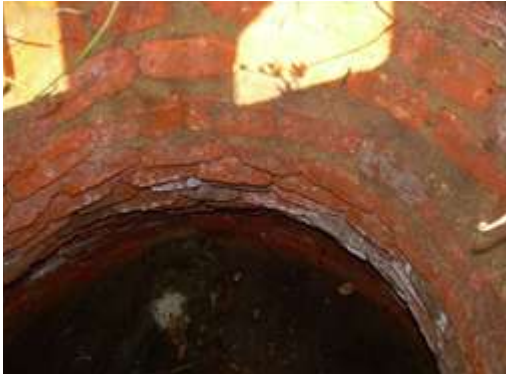
Defect

Infiltration: ☐ None ☒ **Joint** ☐ Cracks ☐ Mortar ☐ Roots ☒ **Wall**

Infiltration: ☐ None ☐ Joint ☐ Cracks ☒ **Mortar** ☐ Roots ☒ **Wall**

Adjustment, Corbel and Barrel infiltration.

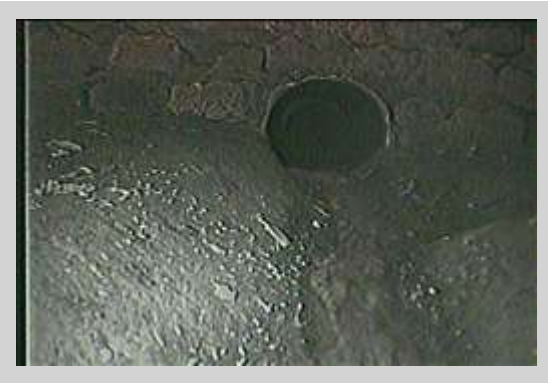
6 in. Circular Gravity Sewer Pipe Out @ 12 O'Clock

Condition: ☐ Sound ☐ Cracked ☐ Root Intrusion ☐ Loose Brick ☒ **Deteriorated**

Infiltration: ☐ None ☐ Joint ☐ Cracks ☒ **Mortar** ☐ Roots ☐ Wall

Barrel deterioration and infiltration.

Infiltration: **Evidence** Pipe Seal Cond: **Cracked**

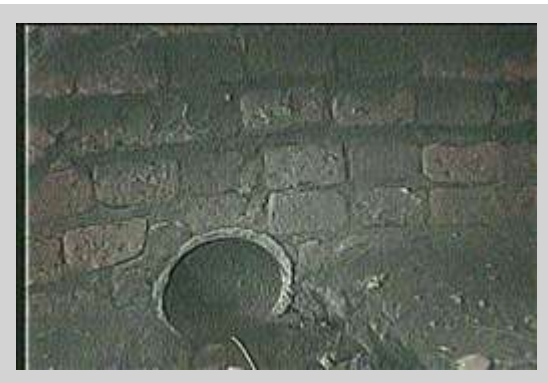
6 in. Circular Gravity Sewer Pipe In @ 3 O'Clock

Infiltration: **Evidence** Pipe Seal Cond: **Cracked**

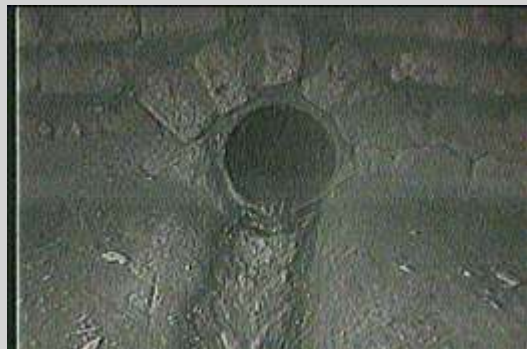
Pipe In @ 6 O'Clock

Infiltration: **Evidence**
